Re: Linnton Plywood Association Facility  
10504 NW St Helens Road, Portland OR  
ECSI No. 2351

**State of Oregon**  
**Department of Environmental Quality**  
**Memorandum**

**Subject:** Staff Report for Completion of Pre-Remedial Investigation  
Linnton Plywood Association/Columbia River Sand & Gravel Facility  
Portland, Oregon  
ECSI – 2351 & 2373

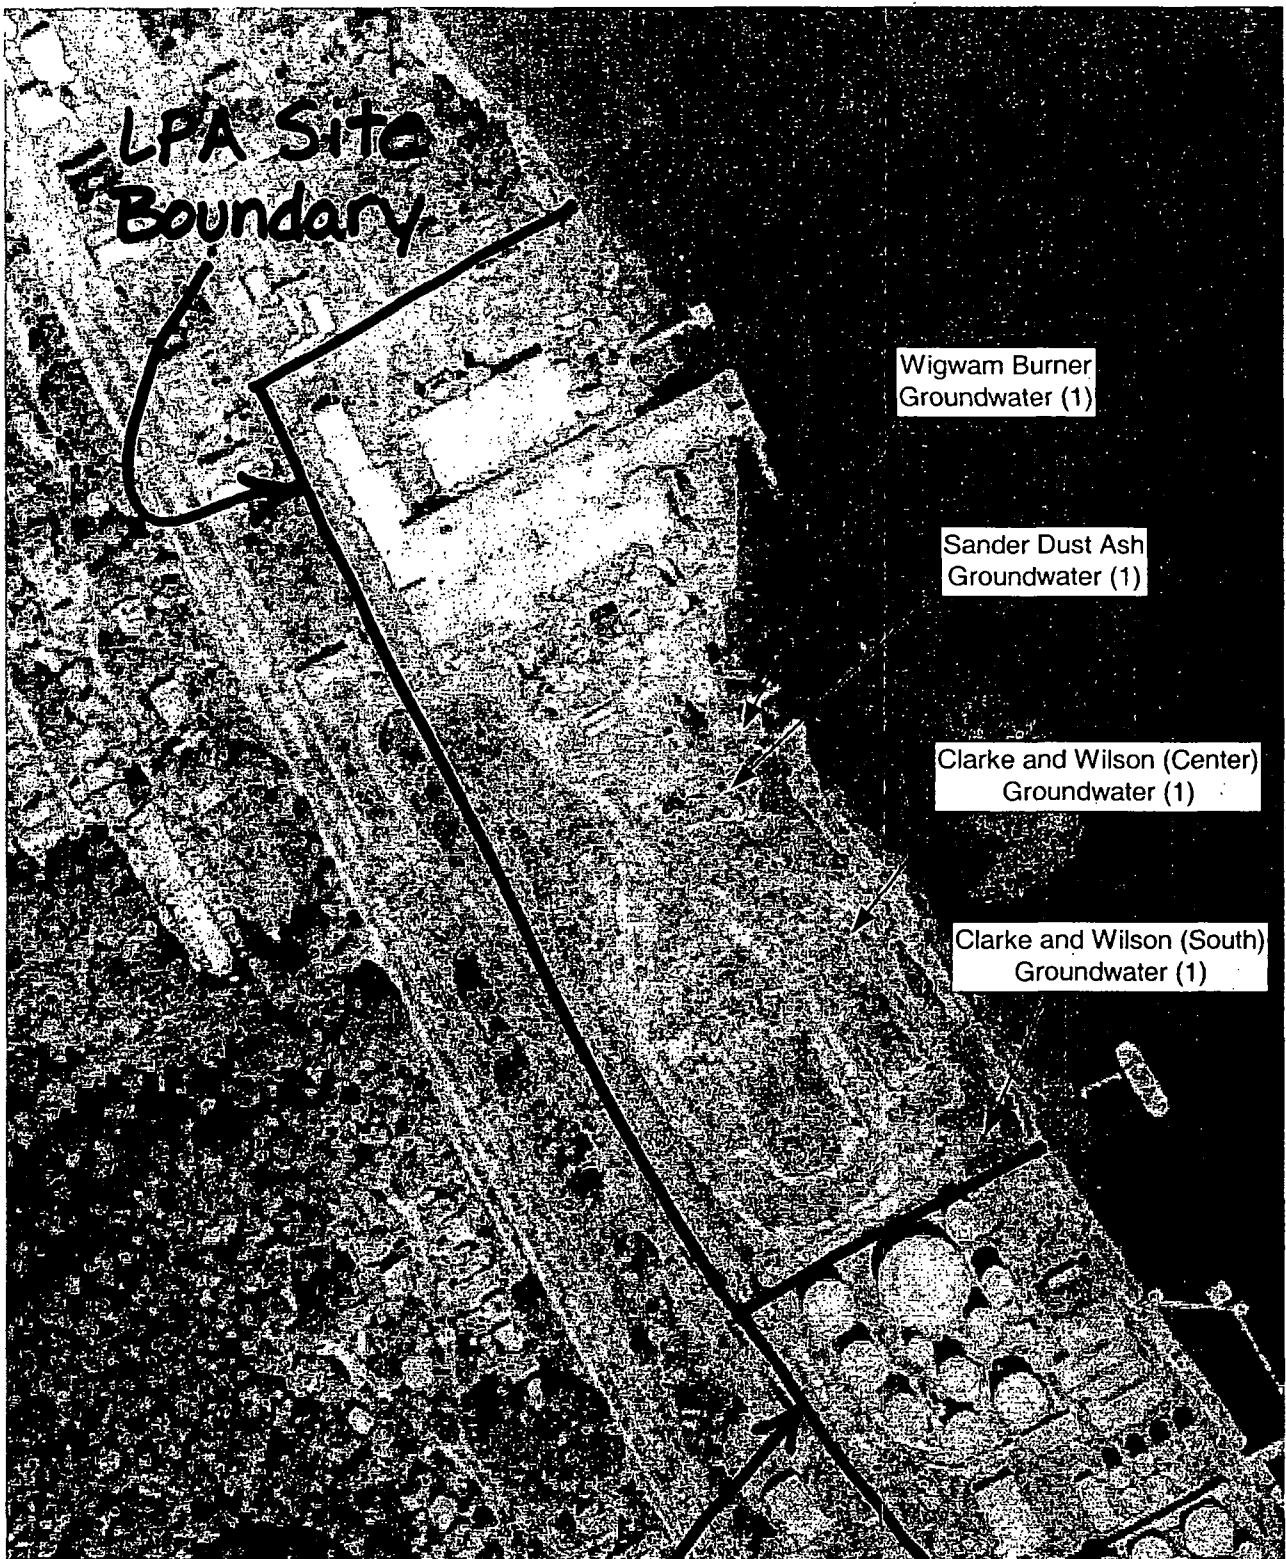
**Figure 3**  
Sampling Locations  
Linnton Plywood Association  
Portland, Oregon

Groundwater samples were collected in October 2001 from key areas along the riverbank based on the results of the historical site use evaluation (see Figures 2 and 3). The samples were collected using a temporary well screen installed with driven-point technique. Due to the presence of silt in the formation, sample volumes collected were limited, and non-turbid samples could not be collected from the temporary well screens. Groundwater samples were tested for site-specific chemicals of interest (COIs). Some samples collected during the October 2001 sampling event, without field-filtering, contained metals and phthalates concentrations slightly above applicable screening criteria (see attached Table 1 – Riverbank Groundwater Results). A second groundwater sampling event was conducted in October 2002, using field-filtered groundwater samples (collected adjacent to the Maintenance Shop, Steam Cleaning, Green End and Wigwam Burner) to determine whether sediment (entrained in un-filtered samples collected in 2001) may have biased the analytical results. Based on a comparison of the October 2002 groundwater data to the October 2001 sample results, the DEQ agrees with CH2M Hill's conclusion that elevated concentrations of some metals and
